Advanced Molecular Imaging -1/13- FSN 88200481 April 2014

URGENT – Field Safety Notice

ADAC Vertex Classic, Vertex Plus, Solus and Vertex V60 Systems

Detector head may drift, resulting in potential patient injury or death

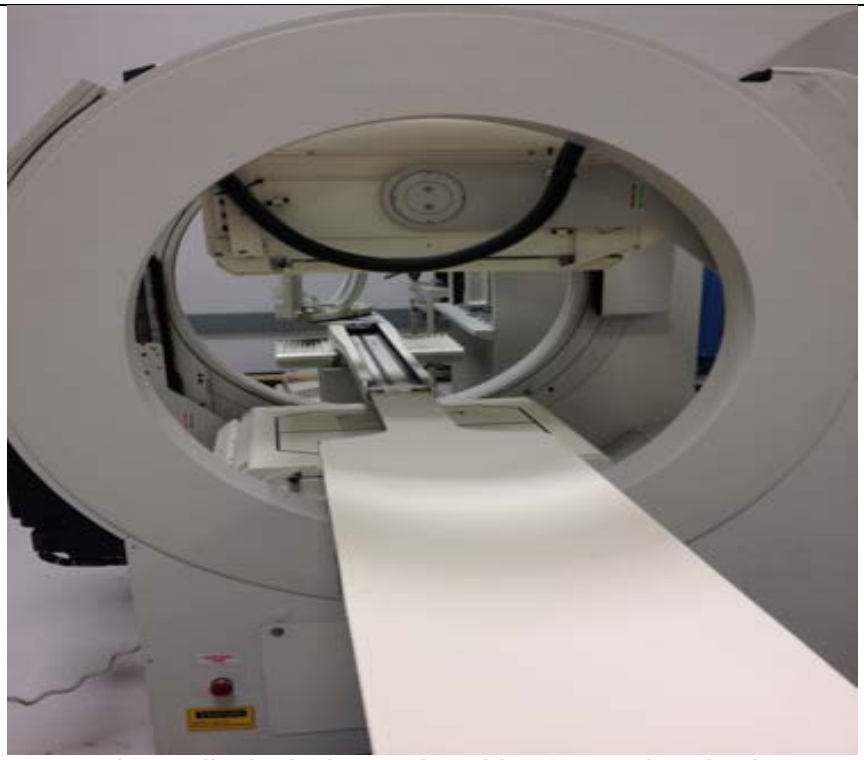
Picture 3: Patient pallet in the lowered position for Total Body Planar procedure

5. Position the patient on the patient pallet, using aids and pillows as necessary.

Warning: Maintain a minimum 5cm distance between the patient and the collimator face of the Anterior/Superior detector.

6. To ensure image quality, maintain patient to detector proximity by using the hand controller to raise the patient pallet height and the Posterior/Inferior detector head during gantry travel of the requested scan length.
